MTL TR 88-6

METALLURGICAL EXAMINATION OF A DIAPHRAGM - LOCKUP CLUTCH PISTON

VICTOR K. CHAMPAGNE, Jr.

April 1988

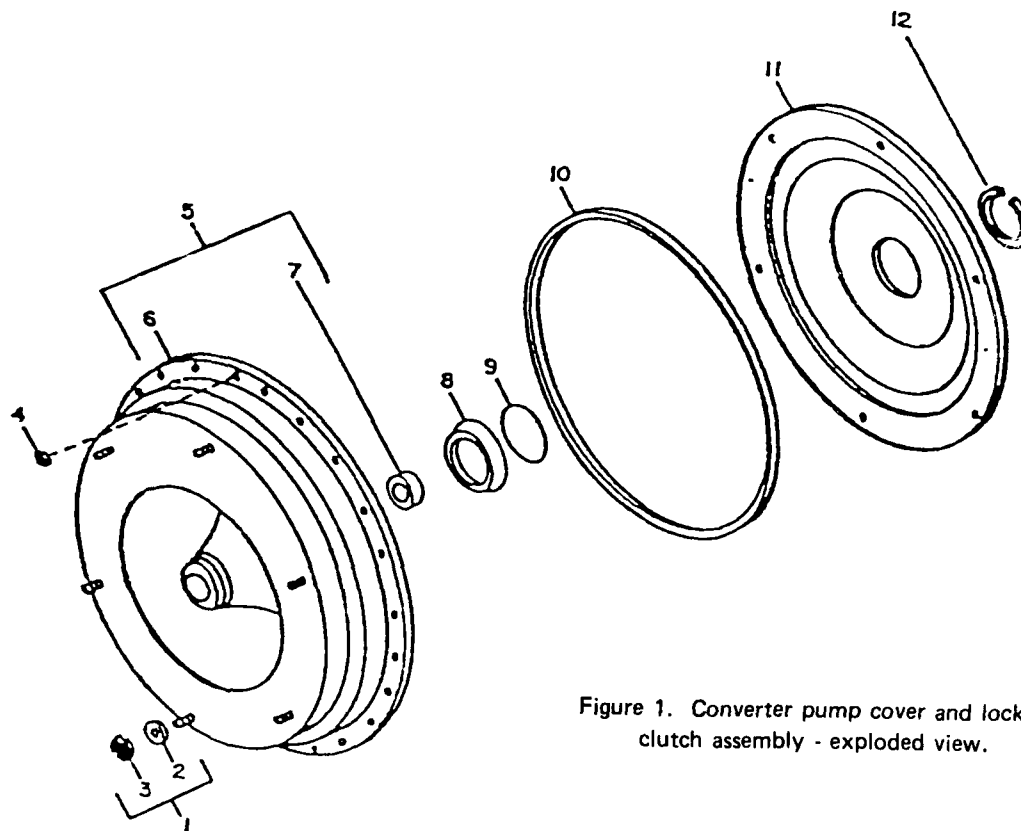
Figure 1. Converter pump cover and lockup clutch assembly - exploded view.

The converter pump cover assembly (Figure 1, Item 5) is a pressed steel assembly with six drive studs at the front to attach it to the engine flex-drive plates. The rear ends of these six studs enter blind holes in the lockup clutch piston assembly (Item 11) causing the cover and piston to rotate as a unit. A center hub enters the end of the engine crankshaft for alignment. Lockup clutch oil pressure applied between the piston and cover, moves the piston against the lockup clutch disk for clutch application.

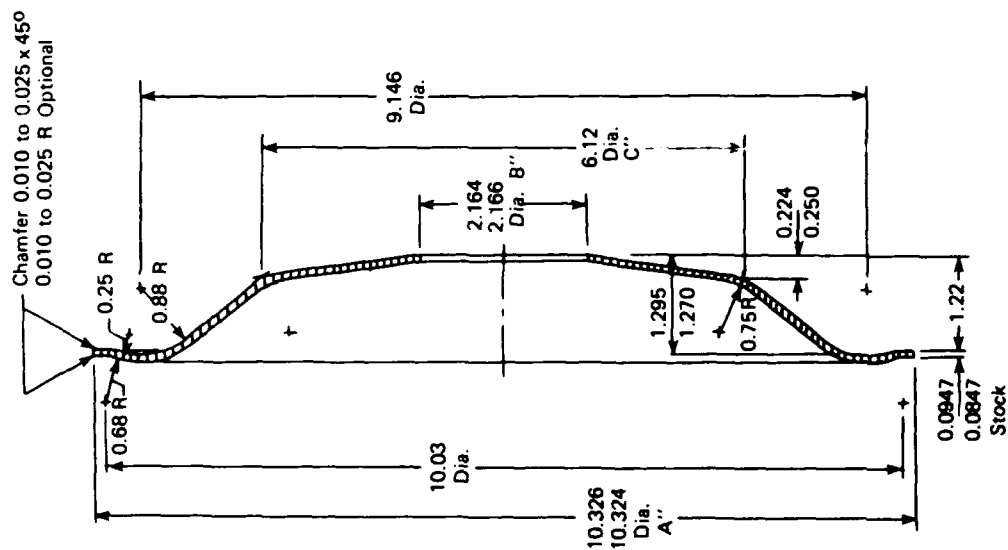
Figure 2. Shows the dimensional schematic of the part and a macrograph in an as-received condition.

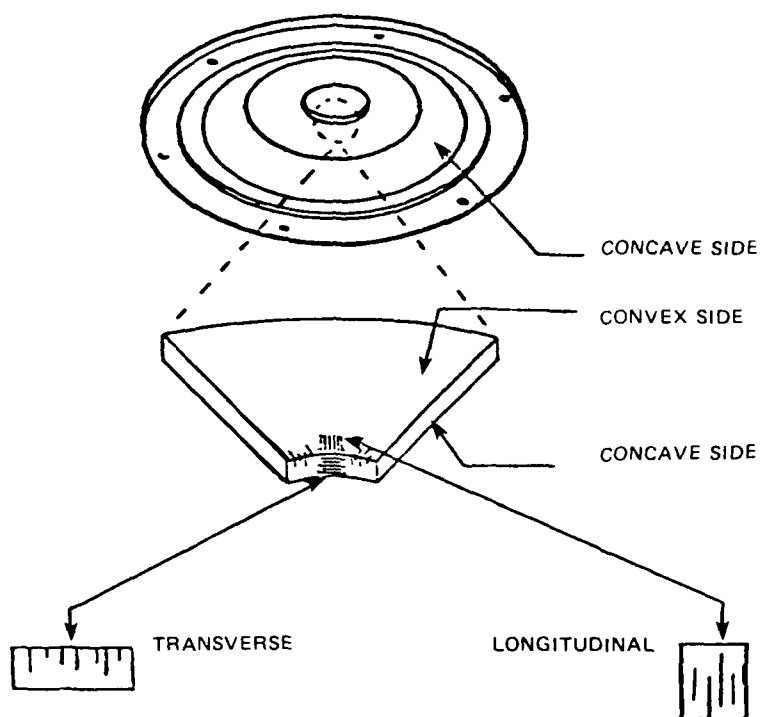
Figure 5. Metallographic sectioning.

Figure 5 is a schematic illustrating the areas where metallographic specimens were sectioned from the inside diameter region of the diaphragm. These samples were polished and etched to reveal the microstructural features of the material. Figures 6 and 7 are transverse and longitudinal sections, respectively. Villela's etchant revealed a typical tempered martensitic structure in both cases. This type of microstructure was expected since the part was austenitized, quenched, and then tempered.

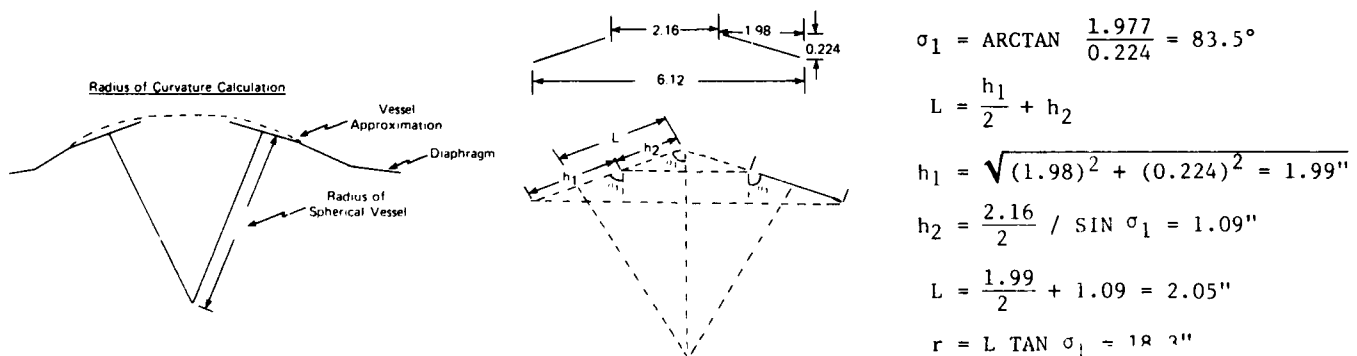
The maximum operating stress in the diaphragm was determined by using the thin-walled pressure vessel theory, where $t = Pr/2t$.⁹ First the radius of curvature of the diaphragm was calculated as shown below:

The operating stress was calculated to be 18.4 ksi.

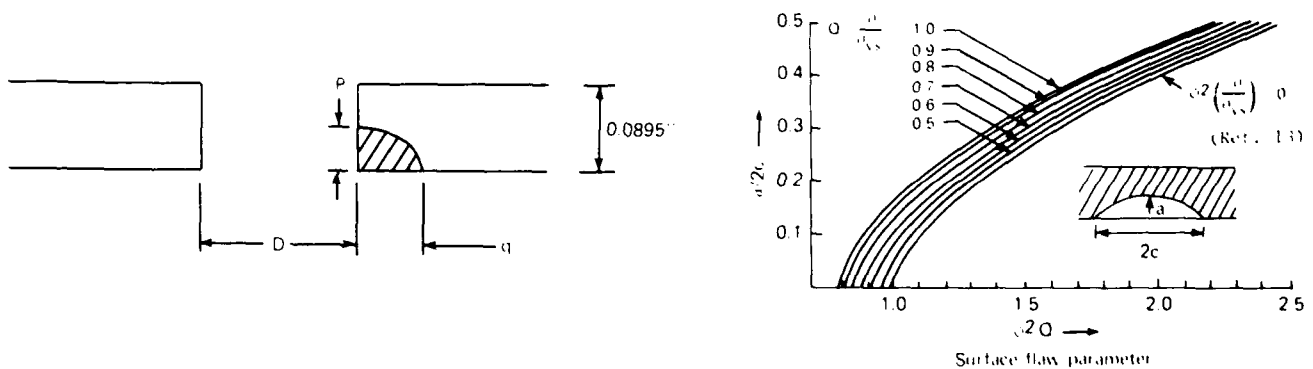
The hole diameter "D" was measured to be 2.165 inches. Various crack parameters were used in calculating the K_I value. The values for "p" and "q" were determined from various measurements taken from Table 6. The stress in the material " σ " was determined by adding the highest value of residual stress listed in Table 5 to the actual operating stress calculated in Section 1. The flaw shape parameter can be derived from the figure shown below:

For a crack where $P = 0.04$ $K_I = 33.4 \text{ ksi}\sqrt{\text{in.}}$
 $q = 0.04$
 $\sigma = 18.4 + 63.6 = 82 \text{ ksi}$
